Reducing Bond Failures Caused by Moisture Vapor Transmission

By: Robert R. Cain

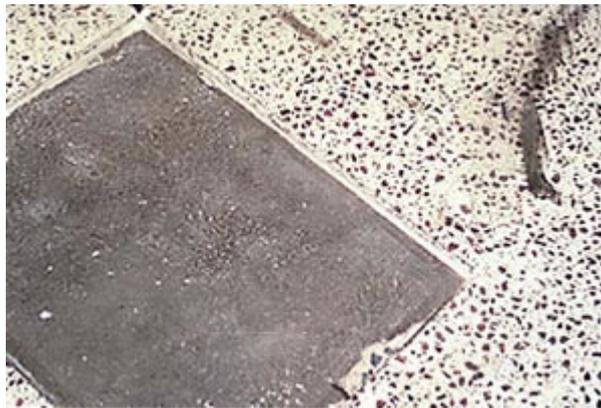
Photo 1 Epoxy Terrazzo Moisture Vapor Failure

Photos #1 and #2 show the effect of moisture vapor transmission on impermeable and permeable floor systems. Photo #1 is an epoxy terrazzo surface (impermeable) which has completely lost bond and has water lying in the exposed area. Photo #2 is also a terrazzo surface, but in this case it is a permeable, cement-based system. Moisture migration is plainly visible around the panels of terrazzo defined by zinc divider strips. Moisture is transmitting along the path of least resistance, but is not affecting the bond or adhesion of the terrazzo to the concrete substrate.

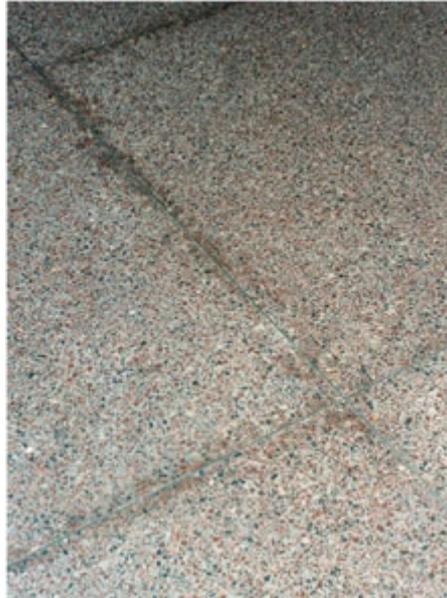
*Photo 2 Moisture Vapor Transmission through Polyacrylate
Terrazzo Joints*
